# Lessons Learned on a Runway Reconstruction Project

**Lessons learned are important elements of a successful project and should be passed on to PB staff. Several steps that were critical to the success of a runway reconstruction project at Pennsylvania's Allegheny County Airport, are described in this article, as is an effective method to repair short cracks that developed above the dowel bars in the transverse runway joints.**

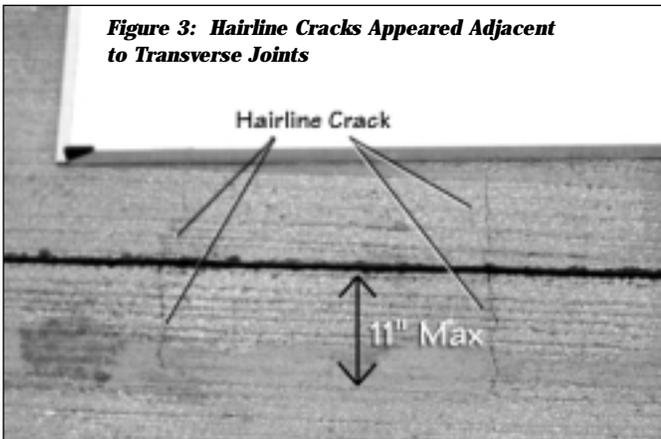
**Figure 3: Hairline Cracks Appeared Adjacent to Transverse Joints**

We noted several hairline cracks adjacent to transverse joints during these cleanup operations (Figure 3). The cracks appeared to be surface cracks ranging from 100 mm (4 inches) to 300 mm (12 inches) in length. They were located directly above the dowel bars. Core samples taken immediately indicated that the cracks were 25 mm (1 inch) to 38 mm (1.5 inches) deep. In some places the cracks went down to the top of the dowels. They occurred only in places where the Bid-Well paver had been used for concrete placement.

We concluded that most probable cause of the cracks was that the concrete surface shrank more quickly than it was supposed to. Windy conditions caused the surface to dry out too quickly, which caused shrinking and cracking. We also concluded that this was a highly localized condition, and the majority of the runway surface was acceptable.

Based on visual examination of the penetration depth of the material, the polymer product, Roadware 10-Minute Concrete Mender™ from Elas-Tech was selected for further testing. It had penetrated to the bottom of the crack easily with its low coefficient of viscosity. It was also applied easily with an application gun and did not require preparatory steps for the crack. The polymer stained the concrete surface amber, however, so we used cement powder to absorb excess material and minimize staining.
