# Lessons Learned on a Runway Reconstruction Project

**Lessons learned are important elements of a successful project and should be passed on to PB staff. Several steps that were critical to the success of a runway reconstruction project at Pennsylvania's Allegheny County Airport, are described in this article, as is an effective method to repair short cracks that developed above the dowel bars in the transverse runway joints.**

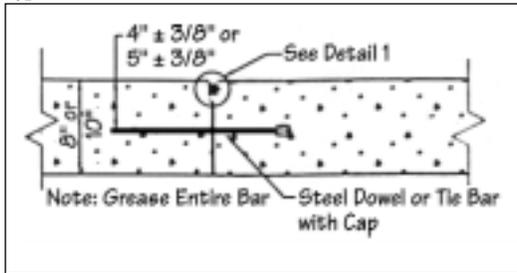
**Figure 1a: Doweled or Tied Construction Joint Type F, not to scale**

✦ **Type F, a full-depth, formed joint** (Figure 1A). FAA pavement design assumes that the smooth formed surface does not provide shear transfer, so the joint dowels are designed to provide the full shear transfer. The smooth dowels are also greased to permit temperature expansion/contraction and movement in the horizontal direction.

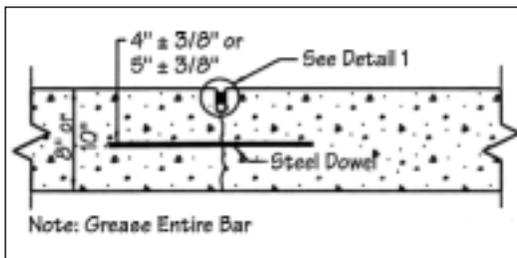
**Figure 1b: Doweled Contraction Joint (Type D), not to scale**

✦ **Type D, a partial-depth saw cut joint** (Figure 1B). The rest of the joint is formed by the cracked concrete below the saw-cut joint surface. The FAA pavement calls for shear transfer within this irregular cracked surface to be provided by the aggregate interlock and assures this transfer by placing "tie bars" to keep the cracked joint tight.

Given the 15-m- (50-foot-) wide slip-form concrete placement, the contractor requested and was given approval to replace the proposed Type F interior doweled construction joints (2nd and 3rd joints from the edge of the pavement) with Type D contraction joints and tie bars. The centerline joint would remain a full depth construction joint

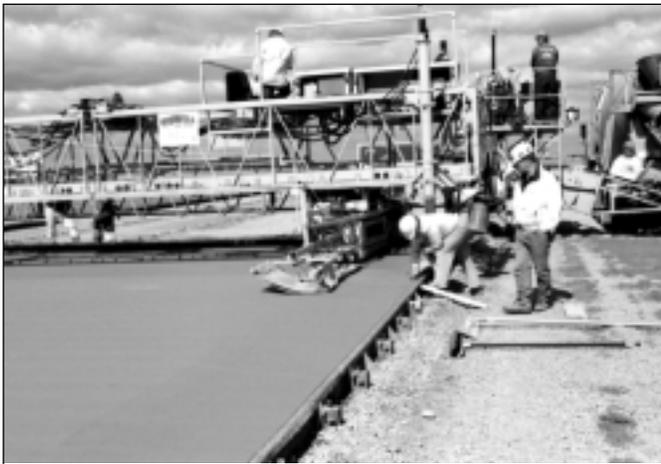
**Figure 2: Paving Train**

The productivity rate of this paving train (Figure 2) was high, with up to 610 m (2,000 feet) of pavement being placed per night, when most of the paving was done to allow the 8-km (5-mile) haul from the concrete plant to the site to take place with no delays. The majority of the paving activities were completed within two weeks.
