**Concrete Floor Repair for Automated Guided Vehicle and Autonomous Mobile Robot Environments: Engineering Principles, Failure Modes, and Performance Validation of Roadware 10 Minute Concrete Mender™**

**A Technical Reference for Engineers, Facility Managers, and Automation Integrators**

**Document Type:** Engineering White Paper

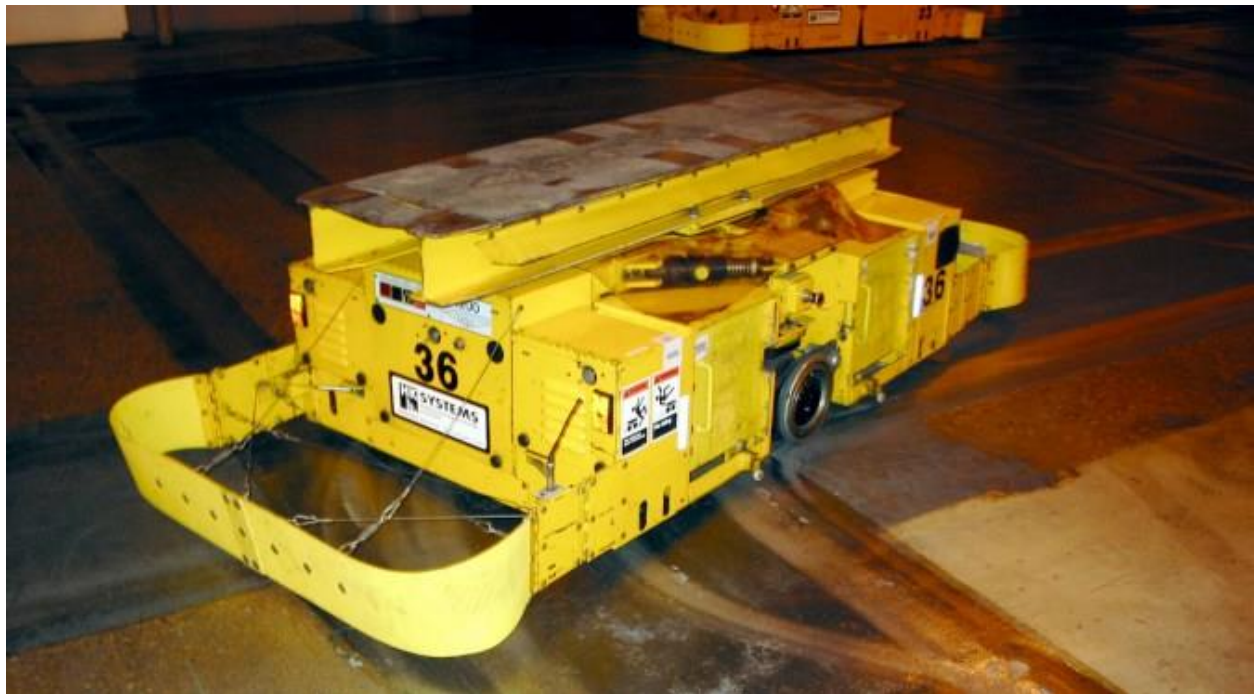
*Figure 1. An Automated Guided Vehicle (AGV) traversing an industrial concrete floor. Floor surface integrity is a primary determinant of AGV navigation accuracy, sensor reliability, and drive system longevity.*
