Another Express Polymers SOLID SOLUTION!

Reconstituting Delaminated Concrete

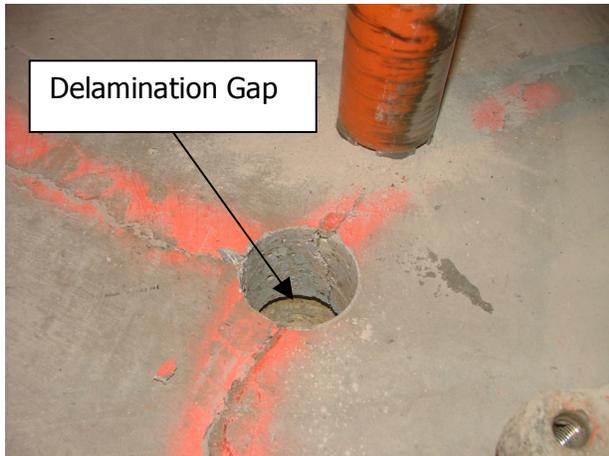
There are many types of delaminated concrete conditions and they can occur for many reasons not always readily identifiable. But delaminated concrete is often the kiss of death and owners often demand replacement. Unfortunately even replacement is no guarantee that it won't happen again. And such corrective action is costly and time consuming. With today's environmental concerns one must question the waste of creating 1.2 tons of CO₂ for every ton of cement that is manufactured. Thus there is one more reason to find a solution to delaminated concrete other than ripping it out and taking the chance that delamination can happen again.

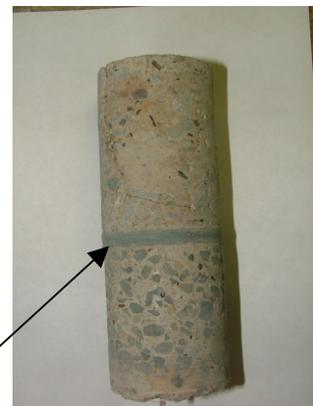
Using Express Polymer products a selected surface area can be repaired and returned to service in minutes with minimal surface preparation. And no other product can provide the penetration capability of ultra thin **10-Minute Concrete Mender**. Our gravity fill technique coupled with the occasional use of 'Nelson Polystuds[®]' to further connect slabs together has proven to be most cost effective. Note the gap on the core in the photo at the right that was gravity filled with Mender from a penetration over 10 feet away.
